RIO GRANDE FLOODWAY
Truth or Consequences Unit, NM

FOUNDATION REPORT, Volume I Report, Photographs, and Appendix A

FOUNDATION REPORT DECEMBER 1992

# RIO GRANDE FLOODWAY, T. OR C. UNIT, N.M. FOUNDATION REPORT RCC DAM, EMBANKMENT DAM, RCC SPILLWAY, AND OUTLET WORKS

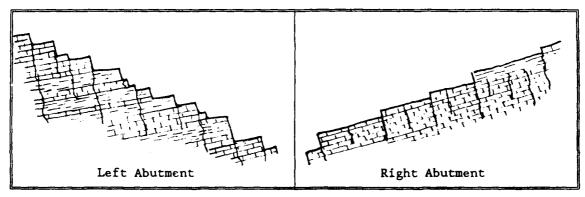
Figure 2-3 Schematic Diagram of "Stair Steps" on the Floor of the RCC Dam Foundation Trench

(ii) The attitude of the joints encountered during excavation, and the tendency for the bedrock to break along bedding planes resulted in a "stairstep" type foundation surface for much of the floor of the foundation trench on the right abutment with numerous, although relatively small, "negative" slopes. A significant amount of dental concrete was required to reshape these slopes in order to accommodate RCC placement. This same situation was encountered on the left abutment, but the result, in this case, was the formation of numerous trough-like features that were easily filled with dental concrete. Figure 2-3 is a schematic diagram of these left and right abutment features.

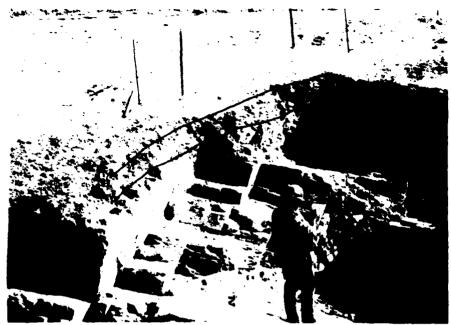
- (iii) MUD MOUNTAIN FANGLOMERATE (Pliocene): A fanglomerate deposited directly onto the Madera formation limestone bedrock along the western flank of the Mud Springs Mountains was exposed at the left abutment of the auxiliary spillway and the left abutment of the RCC dam during excavation (photo 17). It is slightly to well consolidated, light gray to tan, and composed of subangular limestone boulders, cobbles, and pebbles in a sandy marl matrix. Well consolidated fanglomerate was left in place as suitable foundation material.

Photo No. 17 - Looking north at the left side of the auxiliary spillway illustrating an exposure of the Mud Mountain fanglomerate. 29 June 1990

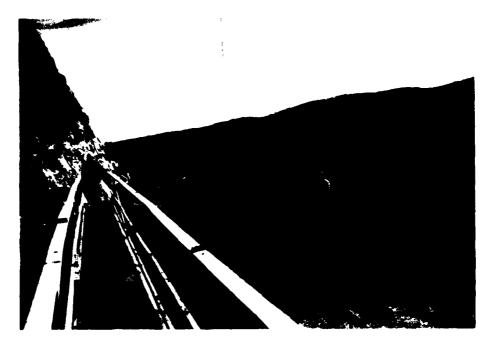
Photo No. 72 - Looking southeast at the left abutment foundation trench illustrating dental concrete placement into the solution cavities. 1 February 1991

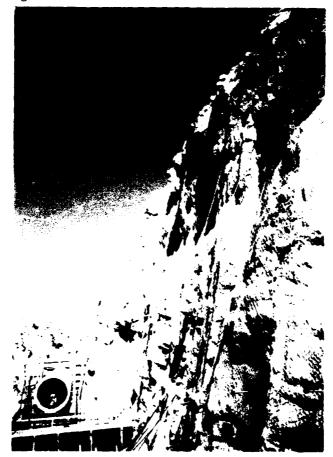
Photo No. 79 - Looking northwest along the alignment of the LLOW illustrating the wire mesh. 21 October 1990

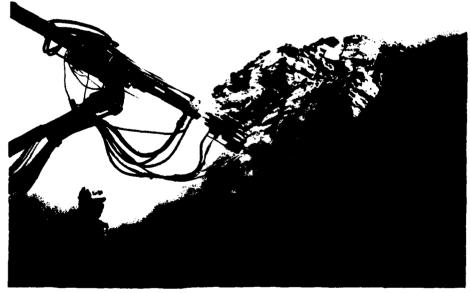
- c. <u>HLOW</u>. Rock bolts were used to anchor joint blocks on the left side of the HLOW to hold these blocks in place until work on the box culvert and U-channel were completed. In May and June 1990, 24 rock bolts ranging in length from 10 feet to 15 feet were installed (photos 82 & 83).

Photo No. 82 - Looking northwest at the left side of the HLOW illustrating drilling for rock bolts. 18 May 1990  $\,$
